Terraces of Douglas Creek, northwestern Colorado:

An example of episodic erosion

W. R. Womack,* S. A. Schumm

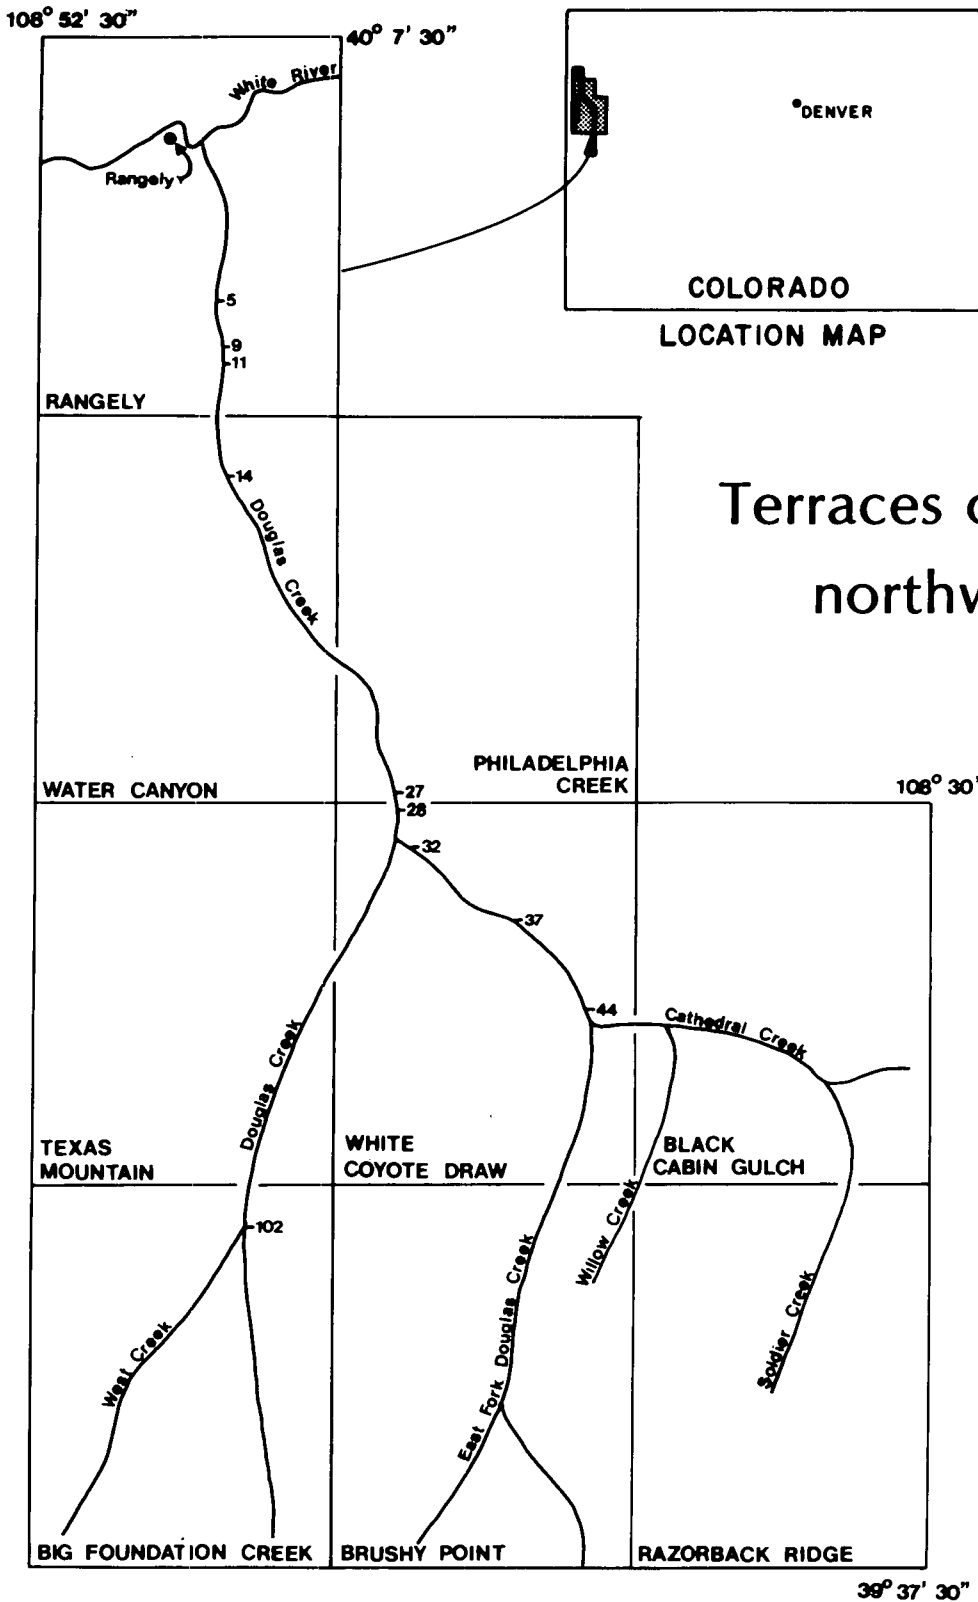
Figure 1. Index map of Douglas Creek. Numbered locations are study sites mentioned in text. Titles of U.S. Geological Survey topographic maps are provided.

Douglas Creek is a tributary of the White River in northwestern Colorado (Fig. 1). It flows north toward Rangely from its headwaters in the Cathedral Bluffs, draining an area of approximately 1,070 km² that is underlain by sedimentary rocks of Cretaceous and Tertiary age.

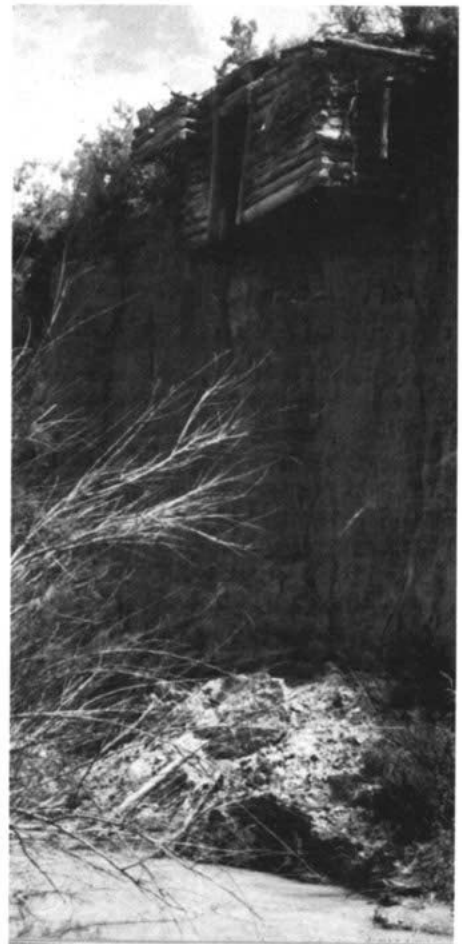
Figure 2. Building, probably a root cellar, constructed about 1900 on floor of Douglas Creek valley at location 32.

An unusual opportunity to investigate the sequence of erosional events in one such valley came about when it was recognized that multiple unpaired terraces exist in the Douglas Creek valley of Colorado (Fig. 1). The presence of a small building at the edge of the arroyo (Fig. 2) suggested that the multiple surfaces, which occur below the surface on which the building was constructed, postdate arroyo cutting and settlement of the area. If this were found to be true, then the recent erosional history of this valley would provide information on the mechanics of the valley incision process that might not be available elsewhere.

The terraces bordering Douglas Creek vary in number at any location from one to seven, including the highest surface or valley floor upon which the old building rests (Fig. 2). The lower surfaces are small (2 to 20 m wide and 10 to 150 m long), discontinuous, and, for the most part, unpaired, but they provide a unique record of channel behavior in this valley. The terraces are cut into older alluvium that is composed of channel, flood-plain, and tributary deposits (Womack, 1975). Several periods of deposition are indicated by the nature of the sediments, but nothing was found that provided a date for this alluvial complex.

The old building (Fig. 2) is all that remains of a homestead that was built in about 1900 near the confluence of East and West Forks (Fig. 1, loc. 32). Aerial photographs show that the main buildings were still standing in 1937, but they were being threatened by lateral migration of the East Fork arroyo. Apparently, when the buildings were constructed adjacent to East Fork near the end of the 19th century, erosion had not progressed up the valley to that point.
